ELECTRONICS RELIABILITY FRACTURE MECHANICS

VOLUME 1. CAUSES OF FAILURES OF SHOP REPLACEABLE UNITS AND HYBRID MICROCIRCUITS

Hughes Aircraft Company
P. O. Box 902
El Segundo, California 90245

Final Report for Period May 1987 - September 1991

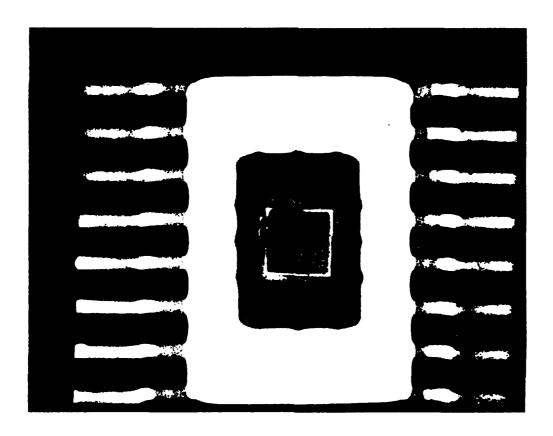
Figure 4-2. Void in P/N 932728-1B, S/N 12

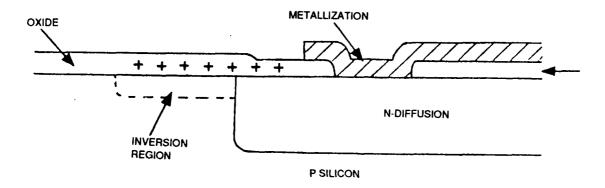
If ionic contamination is present on or in the silicon dioxide that is deposited on semiconductor devices, it can alter the electrical behavior of the semiconductor device. The ionic contamination itself does not conduct current; rather it induces a mirror charge in the underlying silicon. Figure 5-1 illustrates the effect of the ionic contamination. In this illustration, the ionic contaminant is represented by "+" indicating a positive ion in the oxide over the p-n junction. The positive ions attract negative charge carriers in the underlying silicon. In the n-type diffusion, this only tends to make the surface of the n-type silicon even more n-type, an effect known as accumulation. That is, there are more negative carriers than usual which does not significantly affect the electrical behavior of the junction.

Figure 5-1. Sketch of Cross Section of Area on Semiconductor. Sodium lons (+) in the Oxide Induce an Inversion Region in the p-Type Silicon.

In the p-type silicon, the attracted negative charge carriers offset the effect of the positive charge carriers that are present in p-type material. This tends to make the p-type material less p-type. If there are sufficient positive ionic charges in the oxide that are near the surface of the silicon in order to have the maximum effect, the positive carriers can be completely cancelled by the attracted negative carriers. This results in a condition called depletion. If the positive ionic contamination is even higher in concentration, it can attract enough negative carriers to make the surface of the p-type silicon appear to be n-type, a condition called inversion. The area where the inversion occurs is called the inversion region or inversion layer. Since the inversion layer acts as an extension of the n-type diffusion, the shape and location of the p-n junction are uncontrollably altered depending on the distribution of the contaminant in the oxide.

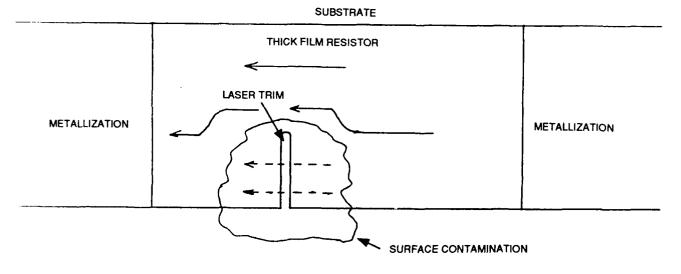
In this failure mechanism the contamination is directly involved in altering the electrical behavior of the circuit element. The contaminant acts as a conductor providing an alternate path for current flow reducing the effective resistance of a thick film resistor as illustrated in Figure 5-2.

Figure 5-2. Sketch of Thick Film Resistor. Surface Contamination Causes Parasitic Current Flow (Dashed Lines) Across Laser Trim Reducing Effective Resistance of the Resistor.

When the thick film resistors are deposited, the value of the finished resistor cannot be controlled precisely enough by geometry alone. Therefore, resistors with tight tolerance requirements are deposited to be lower in resistance than required. The resistor is then trimmed to value using a laser to make a cut into the resistor element. Current is forced to flow around the laser cut through the narrowed portion of the resistor element effectively increasing the resistance of the resistor. The thick film resistors consist of metal oxides in a glassy matrix. When the laser cuts are made, the cut tends to self passivate forming an insulator over the edges of the cut area.

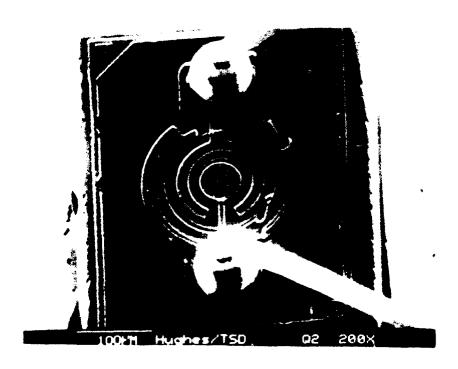
Figure 5-5. SEM Photograph of Transistor Q2

Not only is the gain of transistor Q2 far below the specification limit, the matching between the gains of Q1 and Q2 is also well outside of the specification limit. The specification requires that h_{FE1}/h_{FE2} (where h_{FE1} is the gain of Q1 and h_{FE2} is the gain of Q2) should be 0.85 (minimum) and 1.15 (maximum). This ratio for these devices is 4.8.

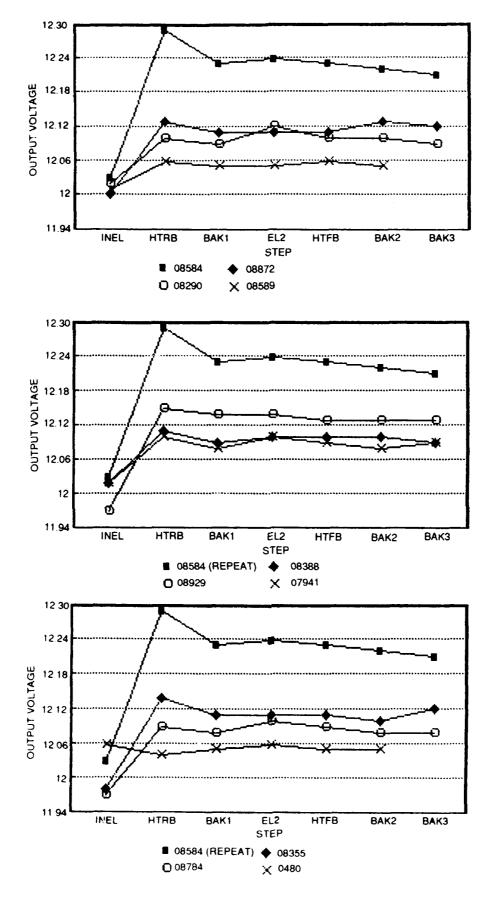
The greatest change was in S/N 8584 which is shown on every graph so that it can be compared to all other devices. Also, note that the output voltages tended to stay at the high output levels all through the rest of the tests, decreasing only slightly for those showing the biggest increase after the HTRB test.

Figure 5-6. Graphs of Output Voltage at Each Step in the Hybrid Contamination Screen for Negative Regulators.

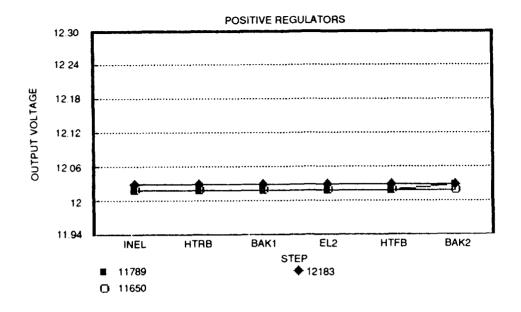
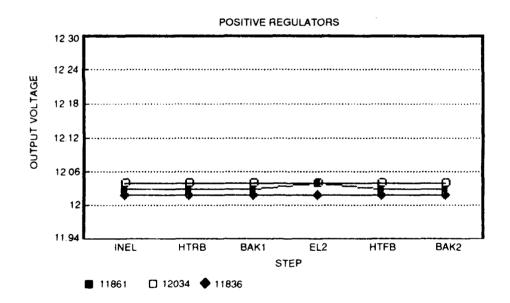
The output voltages of the positive voltage regulators were extremely stable all through the series of tests. Figure 5-7 shows the behavior of the positive regulators. Figure 5-8 shows expanded scales of the change in the output voltages of the positive regulators. Even on the expanded scale no significant trend is noted for the positive regulators outputs.

Figure 5-7. Graph of Output Voltage at Each Step in the Hybrid Contamination Screen for Positive Regulators. (Graph Axes Chosen to be Same as for negative regulators (Figure 5-6) for direct comparison.)

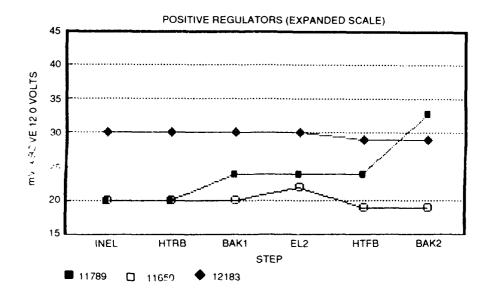
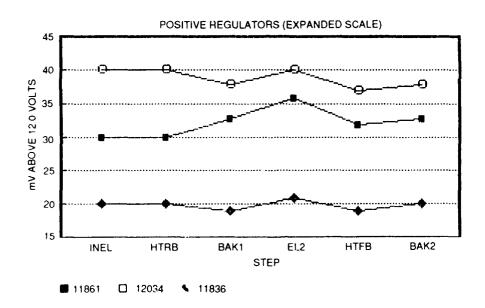
Figure 5-8. Plot of Data Shown in Figure 5-7 on an Expanded Scale.
A Baseline Value of 12.0 Volts has been Subtracted from Each Output Voltage in Figure 5-7.

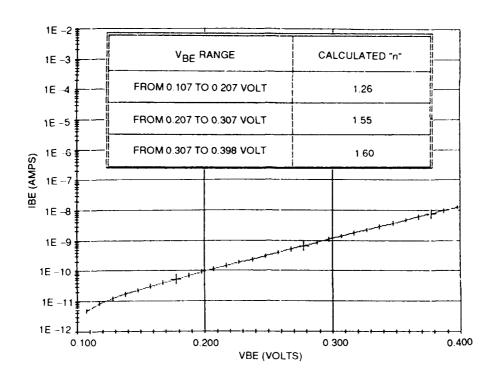
The values of n for Q1 and Q2 were measured using an automated setup that automatically applies the voltage, measures the current and calculates the value of n for various ranges of V_f. Figures 5-9 and 5-10 show the electrical data plots generated by the automated test equipment and the values of n that were calculated for Q1 and Q2. While there were differences in the values of n for device base-emitter junctions, all values were in the range of 1 to 2, verifying that there is no channel associated with either device. It can also be seen that for equivalent forward biases, transistor Q1 conducts considerably less current than Q2. This information is presented below:

Junction Current				
Junction Voltage (VBE)	Q1	Q2		
0.12 V	10 pA	600 pA		
0.20 V	100 pA	40 nA		
0.30 V	1.05 nA	400 nA		
0.40 V	10.05 nA	3.0 uA

Figure 5-9. Plot of IBE vs. VBE for Transistor Q1. The Computed Values of the Ideality Factor, n, are Shown for Various Ranges of VBE.

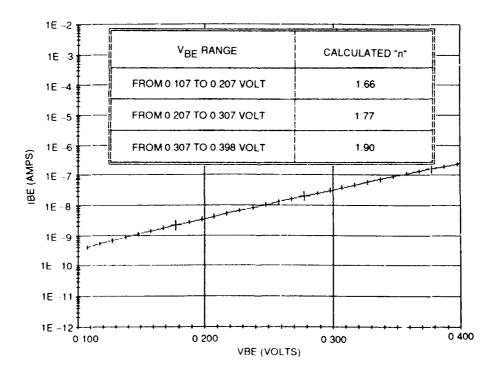
The large difference in the gains of the two transistors is not explained by the small difference in the leakage currents in the base-emitter junctions of the two devices. For such a large difference in gains, several orders of magnitude of difference in the leakage currents would be expected. Also, it should be noted that no evidence of a channel was noted in transistor Q2 during curve tracer measurements of its electrical characteristics.

Figure 5-10. Plot of IBE vs. VBE for Transistor Q2. The Computed Values of the Ideality Factor, n, are Shown for Various Ranges of VBE.

The cause for the higher currents in Q2 is discussed in detail in Section 5.7.3. These higher currents are directly related to the decreased current gain of Q2.

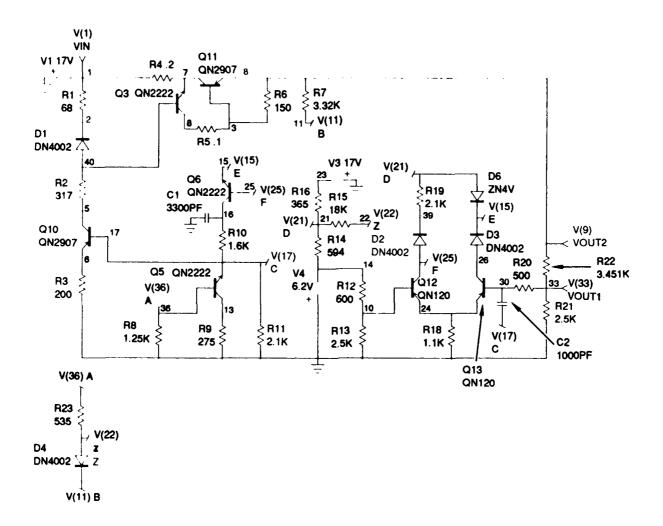
The hybrid was then configured as a -12.00-V regulator with the resulting circuit diagram generated by Microcap shown in Figure 5-11. The individual devices in the Microcap circuit diagram have labels different from those shown in the previous circuit diagram shown for the hybrid. The transistors of interest in the Microcap generated diagram are Q12 and Q13. These transistors will still be referred to by the designation in the first schematic, Q1 and Q2, to try to avoid confusion.

Figure 5-11. Negative Voltage Regulator Circuit Diagram Generated by Circuit Simulation Software. Includes Hybrid Circuitry Plus External Circuitry and Connections Required for a Complete Regulator. Component Labels Differ from Those in Figure 5-3. Q12 and Q13 Correspond to Q1 and Q2 in Figure 5-3. (6.2 V Zener Diode Replaced by 6.2 V Power Supply.)

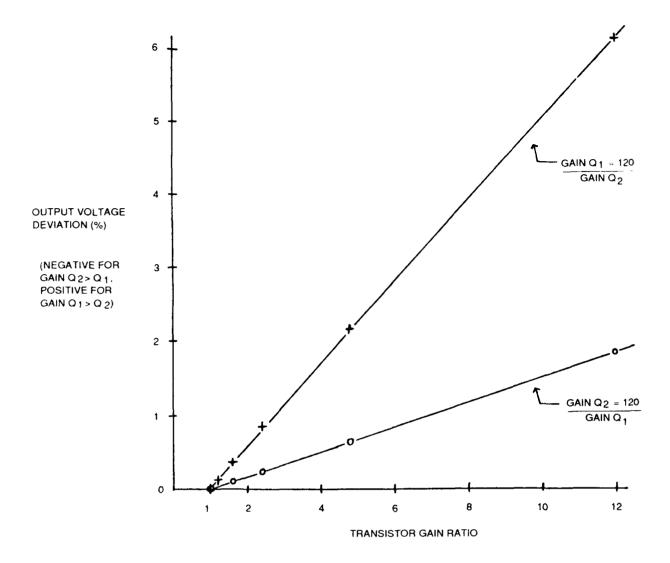
Figure 5-12. Plot of Negative Regulator Output Deviation (in %) vs. Ratio of Gains of Transistors Q1 and Q2. "+" Data Points are for the Condition where Gain of Q1 was Held Constant and Gain of Q2 was Varied. "o" Data Points are for the Condition where Gain of Q2 was Held Constant and Gain of Q1 was Varied. Data for Plots was Generated by Computer Circuit Simulation.

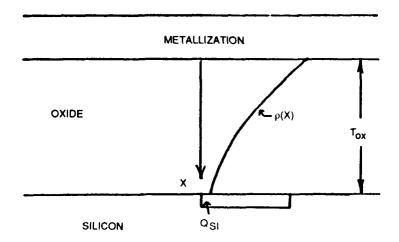
Figure 5-16. Sketch of Cross Section of Surface of Transistor After Sodium has Diffused into the Oxide. The "x" Coordinate is Distance into the Oxide from the Metallization/Oxide Interface. ρ(x) is the Amount of Sodium at Each Layer of Oxide at Distance x into the Oxide. The Sodium Distribution Induces a Charge in the Surface of the Silicon Represented by Q_{SI}. T_{OX} is the Oxide Thickness.

Referring back to Figures 5-15 and 5-16, $\rho(x)$ represents the distribution of sodium ions in the oxide throughout its total thickness T_{OX} . Each point, $\rho(x)$, represents the charge in a layer of oxide x distance away from the metallization. The function $\rho(x)$ was calculated using standard diffusion formulas.

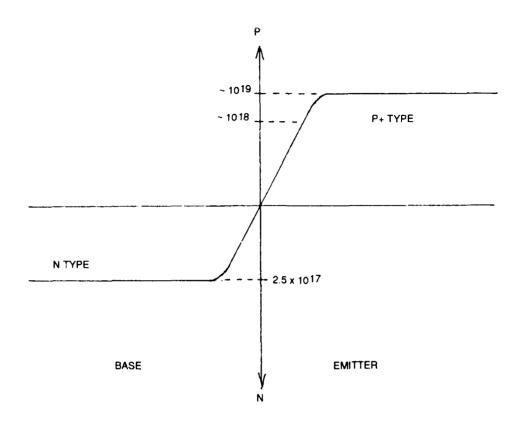
The failure mechanism results when the ionic contamination (sodium) inverts a portion of the p-type emitter area. Figure 5-17 represents the doping concentrations across the surface of the base-emitter junction of the transistor that was degraded by ionic contamination in the negative regulator hybrids. The n-type concentration is about 2.5 x 10¹⁷ atoms / cc in the base and becomes p-type at a concentration of about 10¹⁹ atoms / cc in the emitter. The transition between the two areas is depicted as a linear change (on a log scale) between these two regions. The actual transition is not important. This representation was chosen only for the purposes of the following discussion which will not be extremely dependent on the exact shape of the transition between the two regions.

Figure 5-17. Representation of Doping Levels Across Base-Emitter Junction. Base is N-type and Emitter is P-type with Transition in Between.

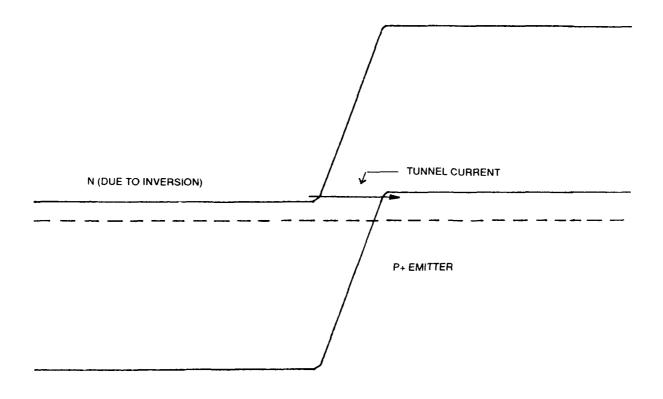
In the case of a junction between an induced n-type region and a heavily doped p-type region, the energy band diagram can appear as shown in Figure 5-20. With the p-type region very heavily doped, the Fermi level lies within the valence band as shown. The induced n-type region is physically very close to the p-type region since it is an inverted portion of what previously was a part of the concentration gradient between normal p- and n-type regions. Under these conditions, the probability of quantum mechanical charge tunneling between the p- and n-type regions becomes significant. (Even for typical junctions there is a probability for tunneling between the two regions. However, because of the differences in the energy levels and the distances involved, this probability is extremely small. Therefore, the contribution of tunneling current to junction current under typical conditions is insignificant.)

Figure 5-20. In a p-n Junction with Heavy Doping (in this Case the p-Type Material is Heavily Doped) the Fermi Level (Dotted Line) Can Lie Within the Valence Band. The n-Type Region, Formed by Inversion of a Portion of p-Region, is Very Close to the p + Region. In this Situation, the Quantum Mechanical Tunneling Probability Becomes Significant.

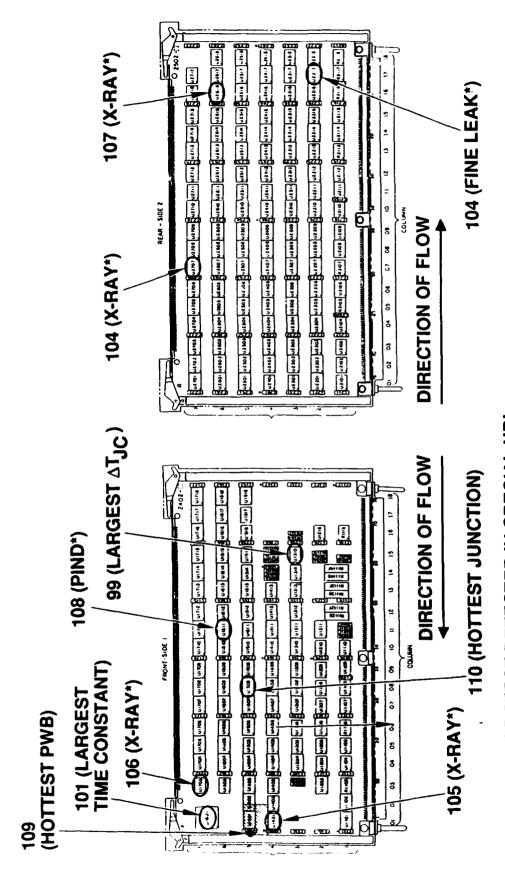
Figure 6-8. Highest Case/PWB Temperatures (°C) on Digital Module During CERT

Thirty thermocouples were mounted with epoxy on the modules -10 on each of the digital modules and 5 on each of the analog modules. The locations, shown in Figures 6-8 and 6-9, were chosen on the basis of the thermal analyses and the special inspection of the parts:

*REJECTABLE DEFECT DETECTED IN SPECIAL NDI

The module underwent nearly 500 CERT thermal cycles, between ambient temperature and temperatures much higher than in normal flight (see Figures 6-8 and 6-9) without failure.

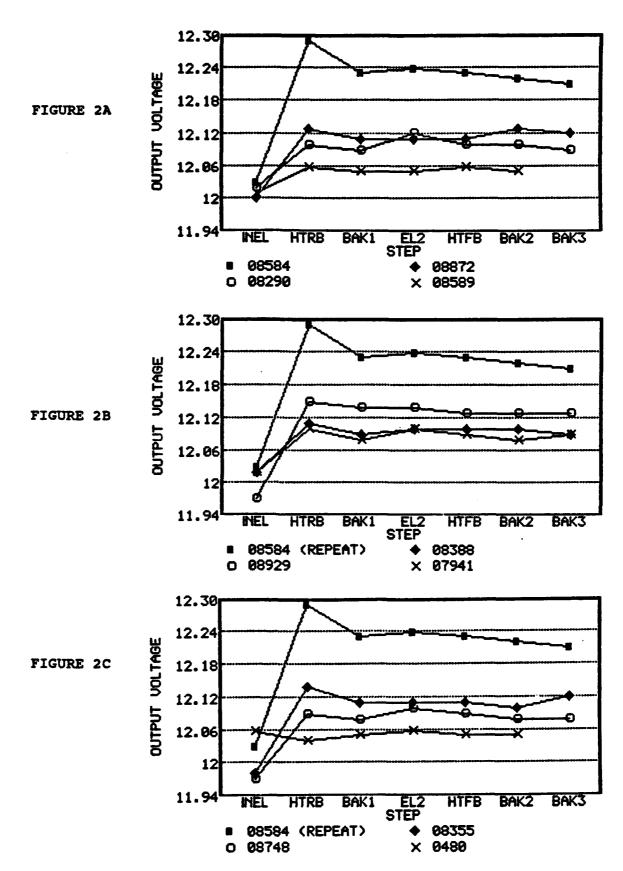
GRAPHS OF OUTPUT VOLTAGE FOR EACH HYBRID S/N AT EACH STEP IN THE HYBRID CONTAMINATION SCREEN.

The hybrids selected for location U2 in the specially fabricated/inspected SRUs are S/Ns 7941 (Figure 2B) and 8355 (Figure 2C). (All of the field failures analyzed were U2 hybrids.) For both of these S/Ns, the HTRB caused the output voltage to shift more than the amount allowed by the hybrid specification (0.06V) but less than the allowable amount at the module level (0.25V). In other words, the hybrid output voltage shift was not large enough to cause a module failure.

The hybrids selected for location U3 are S/Ns 8872 (Figure 2A) and 8388 (Figure 2B). The HTRB caused the output voltage of these S/Ns to shift 0.12V.

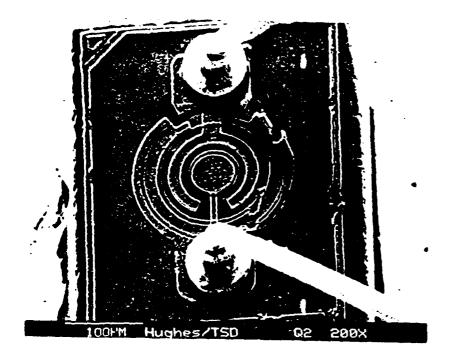
FIGURE 3. SEM (Scanning Electron Microscope) photograph of one of the transistors in the matched pair.

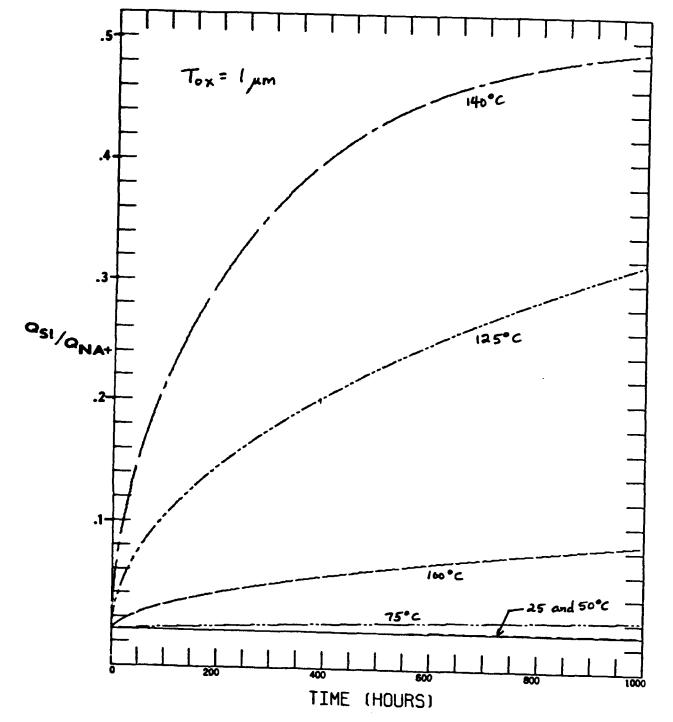
Figure 6 is a graph generated from the model showing the relative amount of surface charge induced in the silicon versus time for various temperatures under conditions of normal hybrid bias or no bias. For a particular initial sodium ion concentration, the time required for this to have its maximum effect even at a temperature of 125°C would be several thousand hours under conditions of normal hybrid bias or no bias.

FIGURE 6. OUTPUT FROM COMPUTERIZED MODEL OF SODIUM ION DIFFUSION. Q_{SI}/Q_{NA+} (CHARGE INDUCED IN SILICON (Q_{SI}) NORMALIZED TO INITIAL SODIUM ION CONCENTRATION (Q_{NA+})) VERSUS TIME FOR VARIOUS TEMPERATURES IS PLOTTED. OXIDE THICKNESS (T_{OX}) IS ONE MICRON.

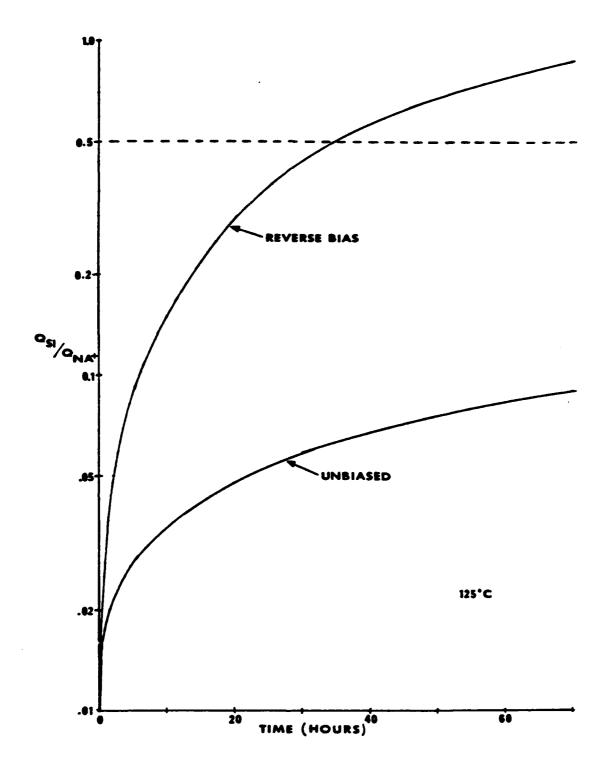
The model for the mobile sodium ion concentration was modified to include the effect of a reverse bias field. This modification predicted that the HTRB time of 48 hours at 125°C would drive the sodium ions beyond the halfway point as illustrated in the graph shown in Figure 7.

FIGURE 7. PLOT OF DATA FROM MODEL OF SODIUM ION DIFFUSION COMPARING REVERSE BIASED OPERATION TO UNBIASED (OR NORMAL BIAS) OPERATION. FOR UNBIASED OPERATION, THE CURVE ASYMPTOTICALLY APPROACHES $Q_{\rm SI}/Q_{\rm NA+}=0.5$. UNDER REVERSE BIASED OPERATION, THE CURVE CROSSES THIS POINT AT ABOUT 35 HOURS.

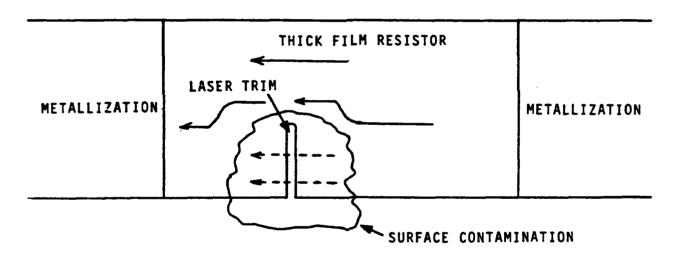
Other failed negative regulator hybrids were determined to have failed from surface contamination which caused the resistance of a thick film resistor in the hybrid to decrease. This resulted in the hybrid output voltage becoming less negative until the module containing the hybrid failed.

A model for the surface contamination failure mechanism has been developed which is similar to the ionic contamination model. In the model for surface contamination, a contaminant diffuses or migrates to a location where it is bridging portions of a thick film resistor which are normally isolated. Initially, the sketch that was used for this model showed a serpentine resistor pattern with the contaminant bridging portions of the pattern. It has been modified to show contaminant bridging a laser trim line as illustrated in the sketch in Figure 8. The basic mechanism is still the same; surface contamination bridges an area that is normally not part of the conductive area of the resistor and reduces the resistance.

FIGURE 8. DRAWING OF SURFACE CONTAMINATION ON THICK FILM RESISTOR. SOLID ARROWS INDICATE NORMAL CURRENT FLOW. DASHED ARROWS INDICATE ANOMALOUS CURRENT FLOW CAUSED BY SURFACE CONTAMINATION.
